# FROM THE FIELD

## Steam problems strike again

BY DAN FOLEY CONTRIBUTING WRITER

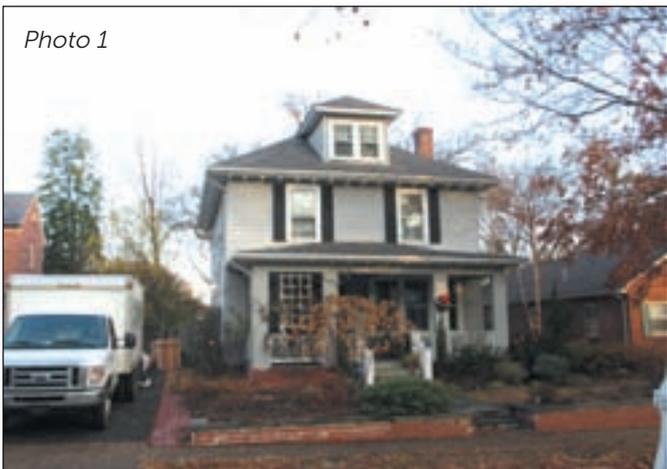
Photo 1

The next morning, I stopped by the customer’s house to survey the job. The house was an American Foursquare, circa 1915, located in Alexandria, Va. (see photo 1). It was heated by an old Hutchison Vapor System, a type of system I run across often in the Washington, D.C. area. This system was manufactured by the Hutchison Vapor Heating Corporation based in Washington, D.C. and has been gone for more than 80 years. I first ran across this type of steam system almost

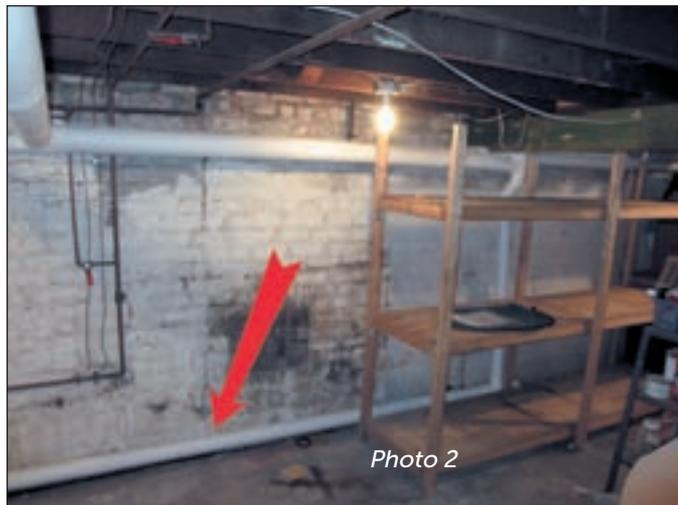
Photo 2

This was a two-pipe steam system that was designed to operate at very low operating pressure, ounces of pressure rather than pounds. There were no traps on the radiator outlets (see photo 2). Steam was kept out of the dry returns by a combination of graduated inlet valves (see photo 3) that would only allow a metered amount of steam into the radiators. The oversized radiators would condense the steam before it reached the outlet at a very low operating pressure of approximately six ounces. There was no main vent. The air was vented into the chimney, aided by the draft of the chimney. The remnant of this vent pipe is still visible (see photo 4). A boiler return trap originally returned water to the boiler when pressure got too high. This boiler return trap was no longer there, perhaps removed by the previous installer not knowing the importance of this device.

them wet returns (see photo 2). This solved the water hammer problem.

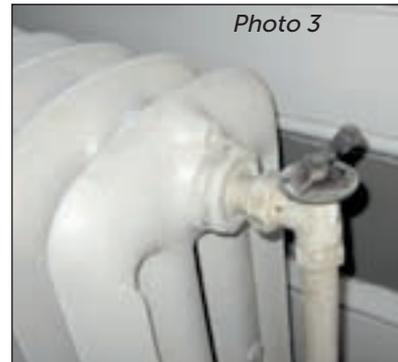
Photo 3

I noted that some of the graduated inlet valves were stuck and a couple had been replaced with hot water radiator valves. Again, while this was a contributing factor, it was not the primary cause. I traced the steam main around the basement, which was easier said than done. The client, to put it nicely, had accumulated enough stuff in his basement over the years to qualify for an episode of "Hoarders."

The graduated inlet valves were beyond repair so we replaced them with forged brass steam radiator valves and added steam traps at the outlets to prevent steam from getting into the dry returns (see photos 5 and 6). Since we installed a Vapor-Stat on the boiler limiting maximum pressure to 16 ounces, the steam traps were not absolutely necessary but I thought it prudent to avoid any future problems. These traps will keep steam out of the wet returns regardless of the boiler operating pressure.

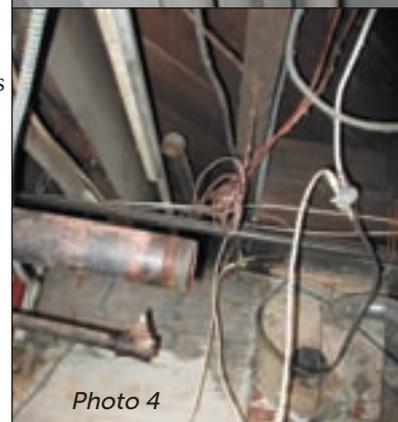
Photo 4

The existing boiler was only about 10 years old but was leaking between the sections. The near boiler piping, while creative, was not what the manufacturer intended. The tee where the main vent used to be now sported a pipe plug (see photo 4). As there was no heat, I did

We installed two high capacity main vents to the system and insulated all exposed heat mains and returns in the basement with fiberglass pipe insulation. We thoroughly cleaned and skimmed the boiler and put it into service. The client marveled at the lack of noise and banging as well as the even heat distribution. Another steam system lovingly restored! ●

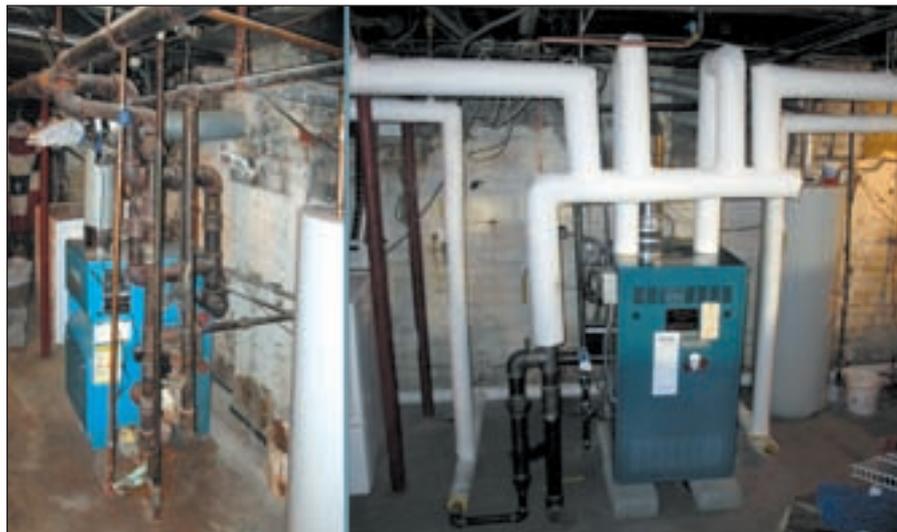
Before (left) and after: A messy, old, patched-up and screwed-up Hutchinson 2-pipe steam system gets a new lease on life with proper rebuilding and a few upgrades to restore it so it would operate to its original excellent levels.

We restored this old vapor system to its former glory by replacing the boiler with a new properly sized Burnham Independence steam boiler. When sizing the boiler, I measured the connected radiation and piping taking into account the existing radiators were about 20 percent oversized to condense the steam. We re-piped the header to manufacturer specifications using both boiler outlets and a drop header to ensure dry steam at the lowest possible velocity. We then re-piped the returns and dropped them down to the floor making
