FROM THE FIELD

Where is the water line?

BY DAN FOLEY CONTRIBUTING WRITER

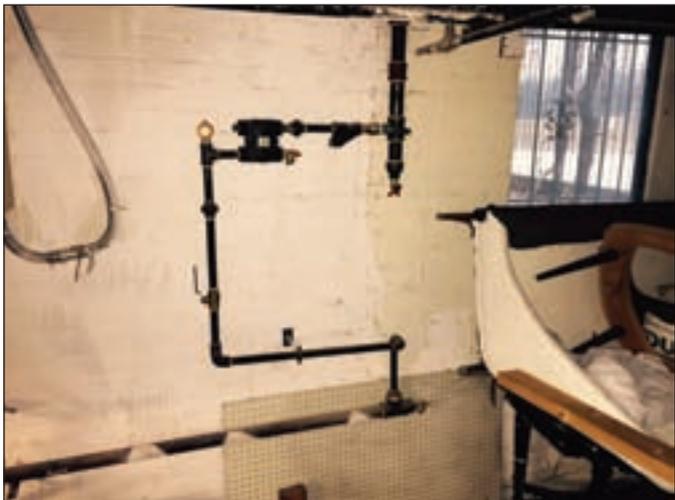
Boiler feed pumps can do a great job of maintaining a steady water line, especially if the new boiler does not hold as much water as the older boiler it replaced. It can store condensate and pump it into the boiler as needed, preventing the burner from shutting off on low water.

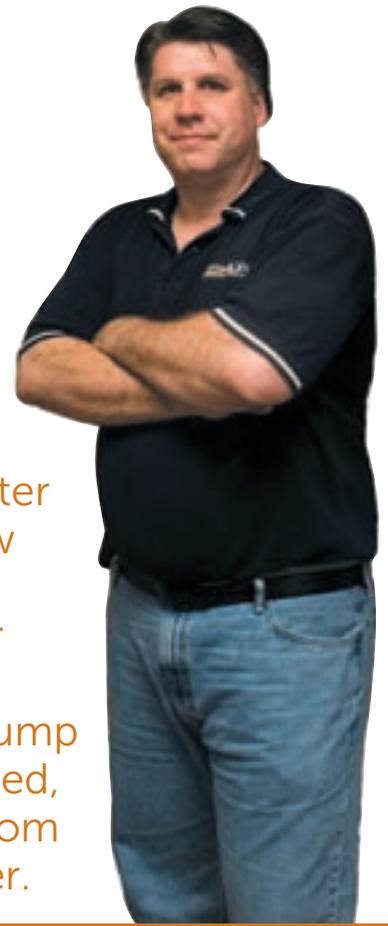
With the main and return pipe flushed out and clear, the steam flowed freely and condensate drained quickly.

With the main and return pipe flushed out and clear, the steam flowed freely and condensate drained quickly. All the radiators on this tier now heated properly and the water hammer disappeared. Steam is a different animal. You can't see what is going on inside the pipes. You must have the imagination to envision what is going on to understand a correct the problem. And, remember to watch that water line. ●
