FROM THE FIELD

Service surprises

BY DAN FOLEY CONTRIBUTING WRITER

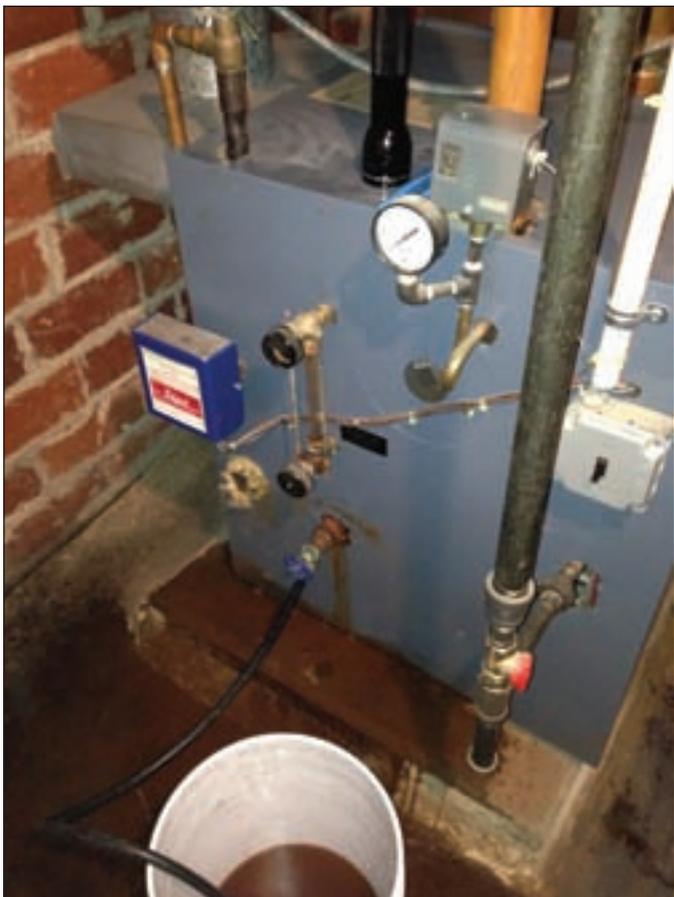
Photo 1: A short hose was screwed onto the boiler drain and the other end was put in the bucket.

I screwed the short hose onto the boiler drain and put the other end into the bucket. (See photo #1) I was still chatting up the owner when I gave the stubborn valve a good hard twist. I went from surprise, to shock, to panic in a split second as the entire valve came off in my hand. Water was spraying everywhere as I tried to shove the valve back into the boiler block, like the little Dutch boy shoving his thumb in the dike.

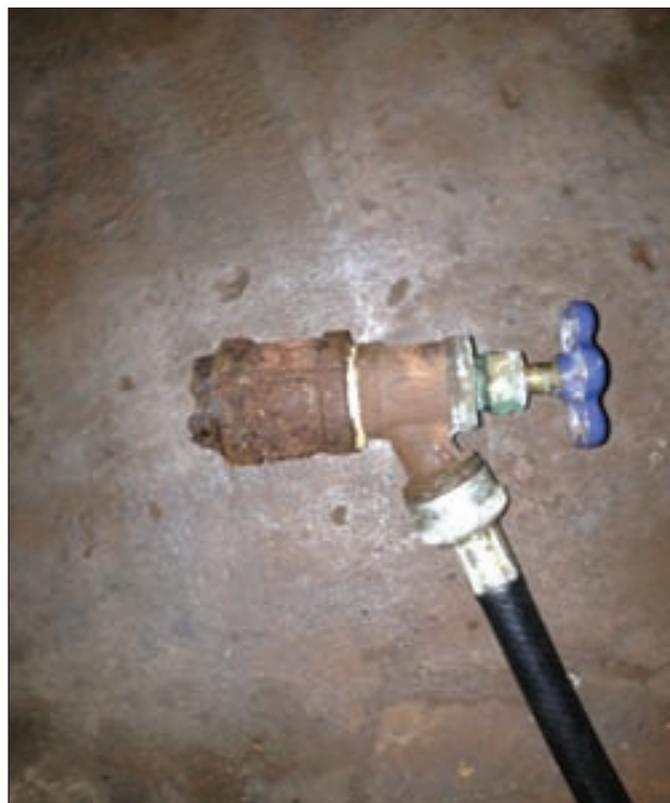
Photo 2: The boiler drain was extended beyond the boiler jacket by a 3/4-inch black nipple and coupling. It had been leaking for some time and caused the nipple to corrode.

By that time, I had managed to drain the boiler, empty countless buckets into the sink, and mop up the rest. I had a chance to find the cause of the situation I found myself in. The boiler drain was extended beyond the boiler jacket by a short 3/4-inch black nipple and coupling. This had been leaking slowly for some time causing the nipple to corrode. (See photo #2) There was not much left by the time I grabbed ahold of it. To his credit, the owner recognized that this was the cause and realized that I just happened to be the last fool to touch it.

There was still a rusted stub of the nipple left in the boiler block. The question was whether the threads in the boiler block were rusted out or if they would be damaged while trying to remove the stub. If so, the boiler would need to be replaced. Mark carefully removed the stub with an easy-out and a 24-inch wrench. He then chased the threads with a pipe tap and threaded a new brass nipple and ball valve with a hose

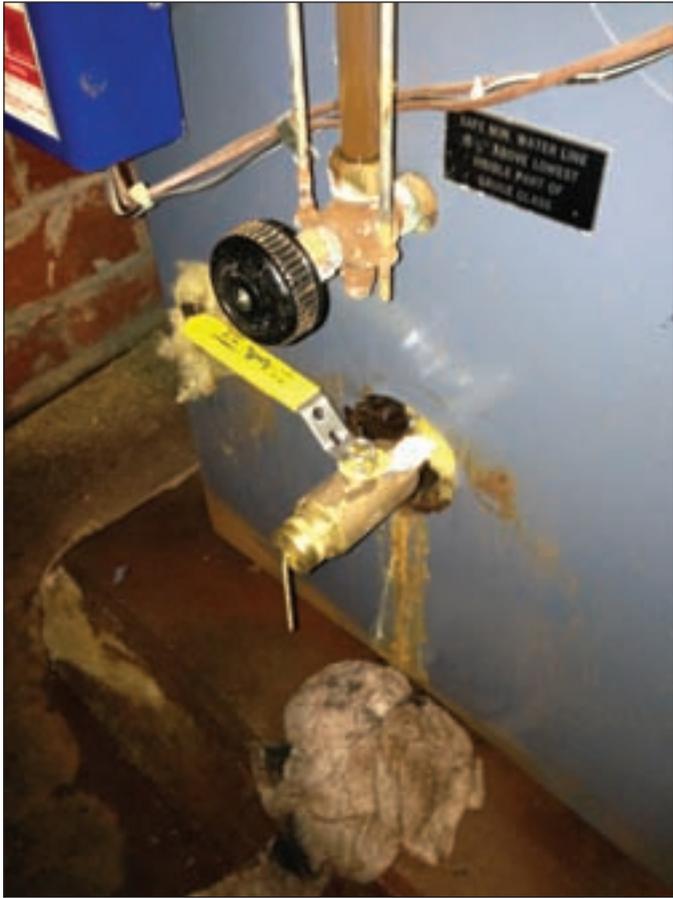
Photo 3: Mark removed the stub with an easy-out and a 24-inch wrench. He then chased the threads with a pipe tap and threaded a new brass nipple and ball valve with a hose end.

end. (See photo #3) To my relief, as well as the owner's, the repair held. I like to use this setup, even on new installs, as it is less likely to create the exact situation we had just dealt with. Also, the ball valve is less likely than a boiler drain to become clogged with mud and sediment.

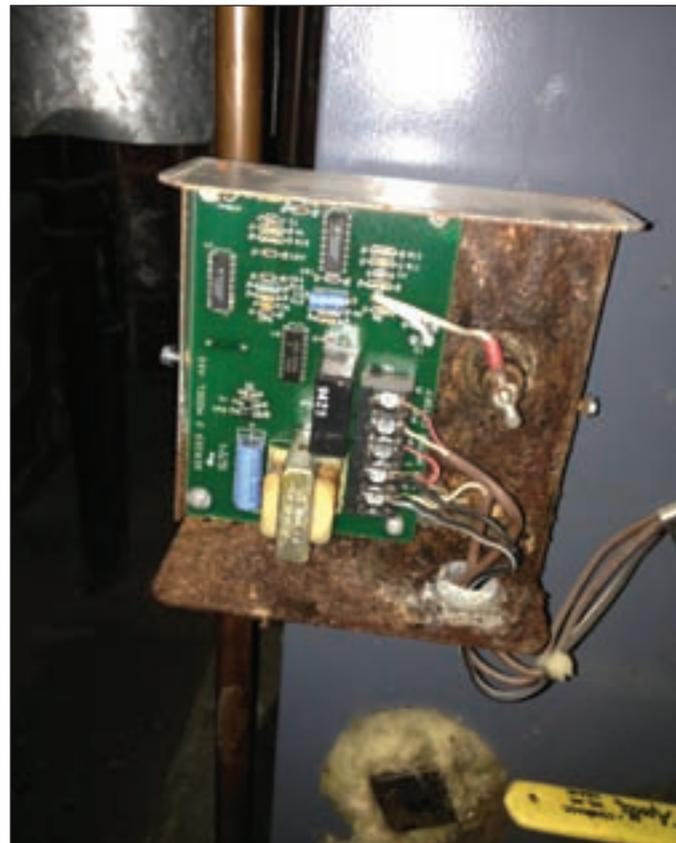
Photo 4: Mark quickly found a leak in the electronic low water cutoff probe that shorted out the circuit board.

We set the boiler water line and flipped the switch, thinking we were done. We watched in amazement as the feeder kicked in and quickly flooded the boiler. This is exactly why I try to avoid declaring a system "fixed" until the heat is back on. Mark quickly found a leak in the electronic low water cutoff probe that shorted out the circuit board (see photo #4). Luckily, he had a replacement part on his truck that resolved the issue.
