FROM THE FIELD

Steam renovation

BY DAN FOLEY CONTRIBUTING WRITER

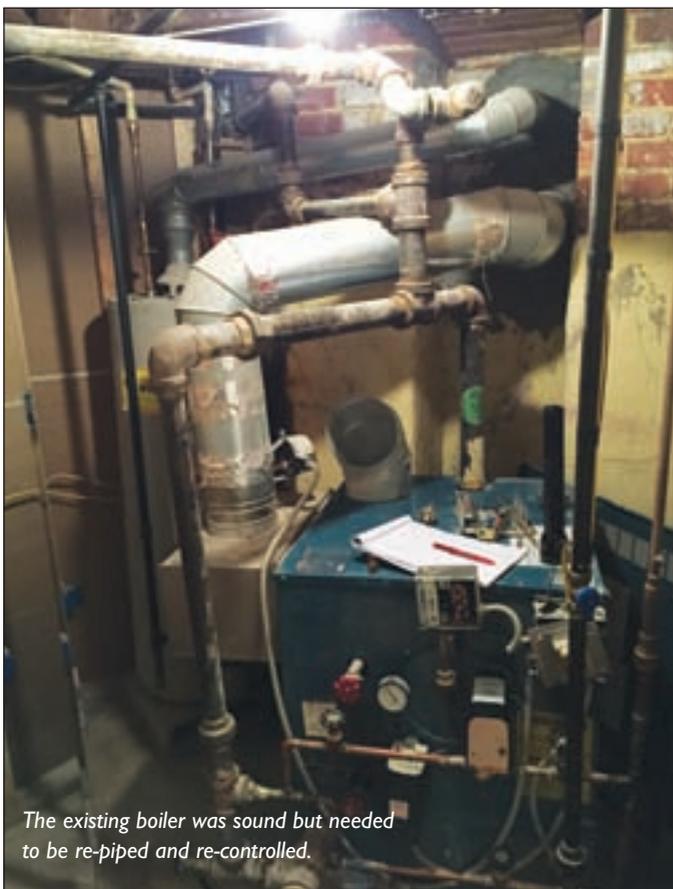
A Burnham Independence Atmospheric Draft Steam Boiler was installed about five years ago, but the near boiler piping was not to manufacturer specifications (see photo). The header was undersized and the counter-flow mains were not dripped. All of the start-up condensate flowed back into the header. A few minutes after steaming, the system would hammer horrendously and the furthest radiators would not heat at all. In an attempt to “force” the steam to these radiators, the pressure setting was raised to 4 psi. This just made the situation worse, as the condensate could not drain against the higher pressure in the undersized mains.

The existing boiler was sound but needed to be re-piped and re-controlled.

There was no fixing this system. The only solution was to cut everything out and start over. The radiators and some of the valves were able to be re-used. The boiler was very dirty and required a complete re-pipe, but was otherwise in sound condition. We did replace the relief valve, pressure-trol, LWCO and all operational controls including the gas valve, as it had operated for five years in under rough-duty conditions.

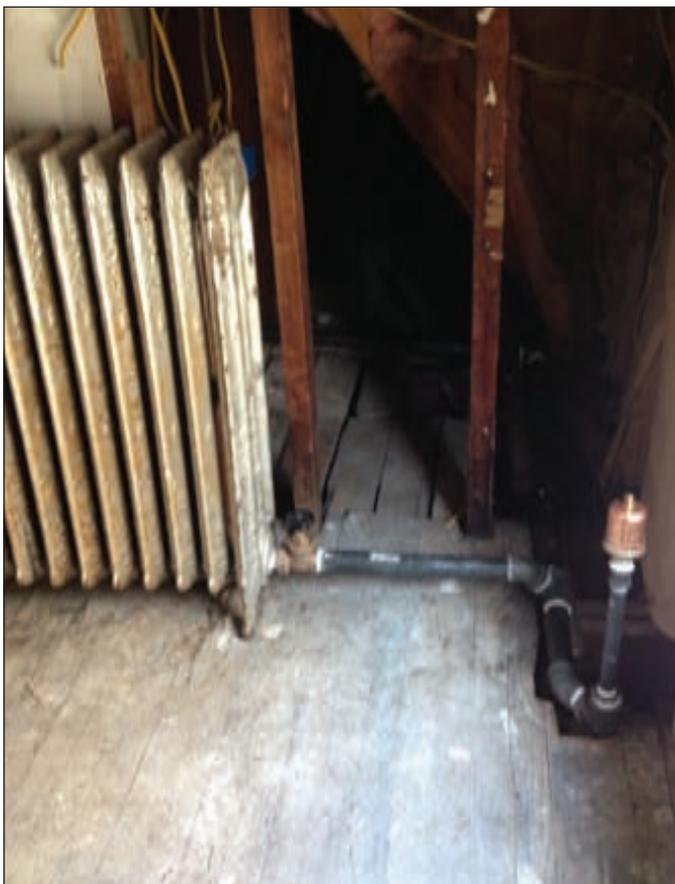
There was one riser that ran the furthest distance from the boiler that would not heat previously. Brian used an old trick and vented the top of the riser with a main vent (see photo). When the system was started, this riser now heated as quickly as the other risers and the previously cold radiators on this tier were toasty warm.
