# FROM THE FIELD

## Old houses, old systems

### Turn of the century Victorian

### Civil War-era home

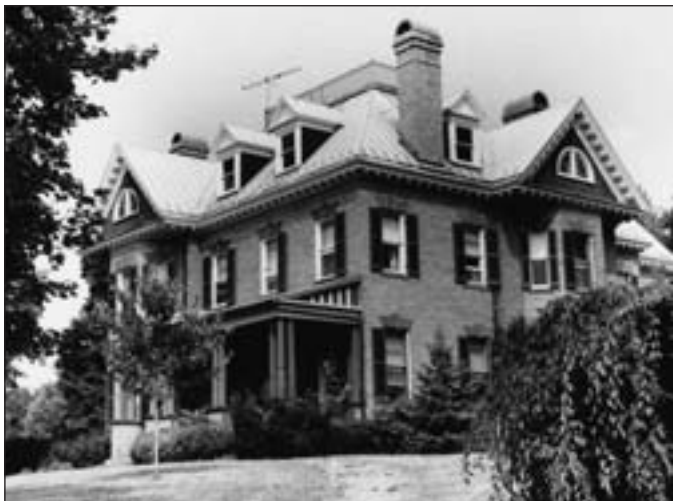
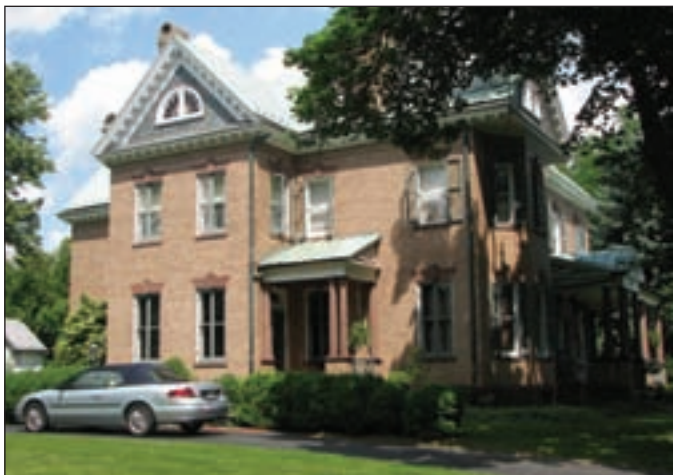
**Photo Set 1:** The first system was a lovely, old Victorian located in Leesburg, Va (top). It was built in 1899, and is listed on the National Register of Historic Places.

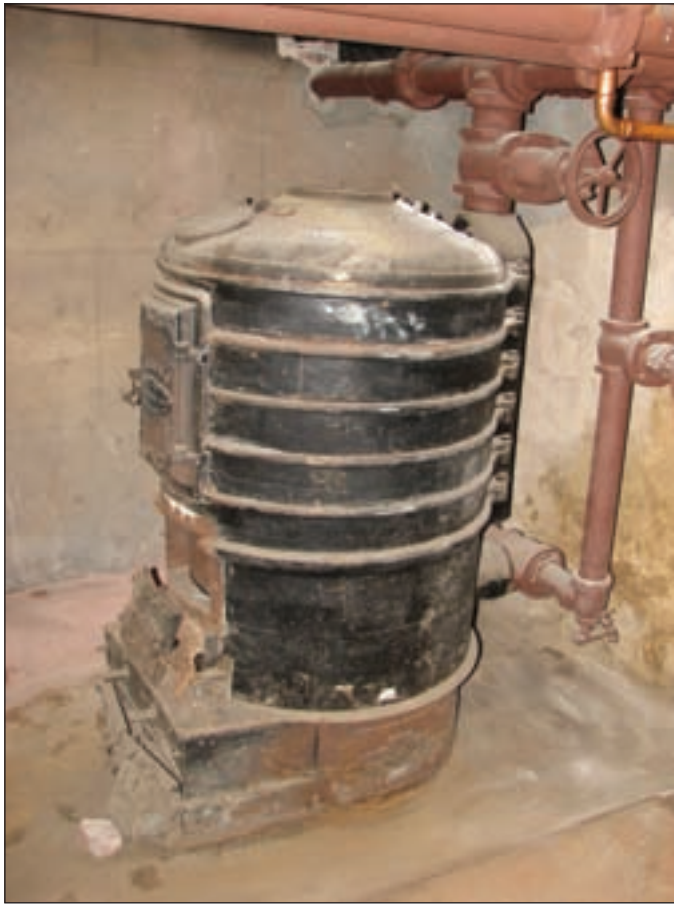
The original Gurney coal-fired boiler was still in place but valved off (See photo #2 on page 148). The heating contractor riveted a steel plate to the boiler. It read, simply, "Hubbard Heating Co. Washington, D.C." The owner wanted to leave this boiler in place for historical value. I surveyed the heating system trying to figure out why two boiler blocks would fail in short order. This was an old gravity hot water system with massive cast iron radiators and large 3-inch and 4-inch steel mains. There was an old riveted steel expansion tank in the attic with the overflow pipe stubbed through the roof.

**Photo 2:** The original Gurney coal-fired boiler was still in place but valved off.

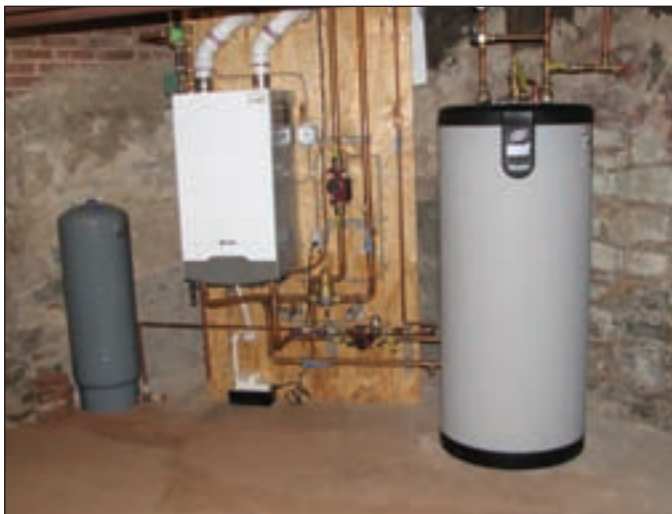
The replacement system consisted of a Triangle Tube Prestige condensing natural gas boiler. We also replaced an electric water heater with a Smart 80 stainless steel indirect fired DHW tank (See photo #3). Because of the low head loss of the system, I piped the supply and return directly into the boiler without a low loss header or primary/secondary piping we would typically use with this type of boiler.

In this case, the goal was to maximize the combustion efficiency of the boiler by returning the lowest temperature return water back to the boiler. Flow is not an issue, due to the low pressure drop of the large mains and radiators. This is a perfect application for condensing boiler technology. These boilers operate most efficiently at low temperatures. This system operates on a reset curve

**Photo 3:** The replacement system consisted of a Triangle Tube Prestige condensing natural gas boiler. We also replaced an electric water heater with a Smart 80 stainless steel indirect fired DHW tank.

with a maximum temperature of 160°F at design conditions.

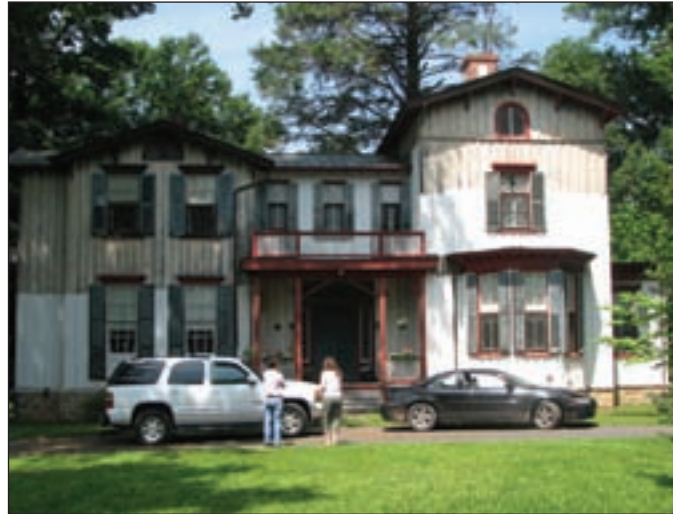
**Photo 4:** The second project was in an Italianate farmhouse built in 1860. The house is located in Thurmont, Md., about an hour north of the city, and is still in the same family as the original owner.

The second project was in an Italianate farmhouse built in 1860 (See photo #4). The house is located in Thurmont, Md., about an hour north of the city, and is

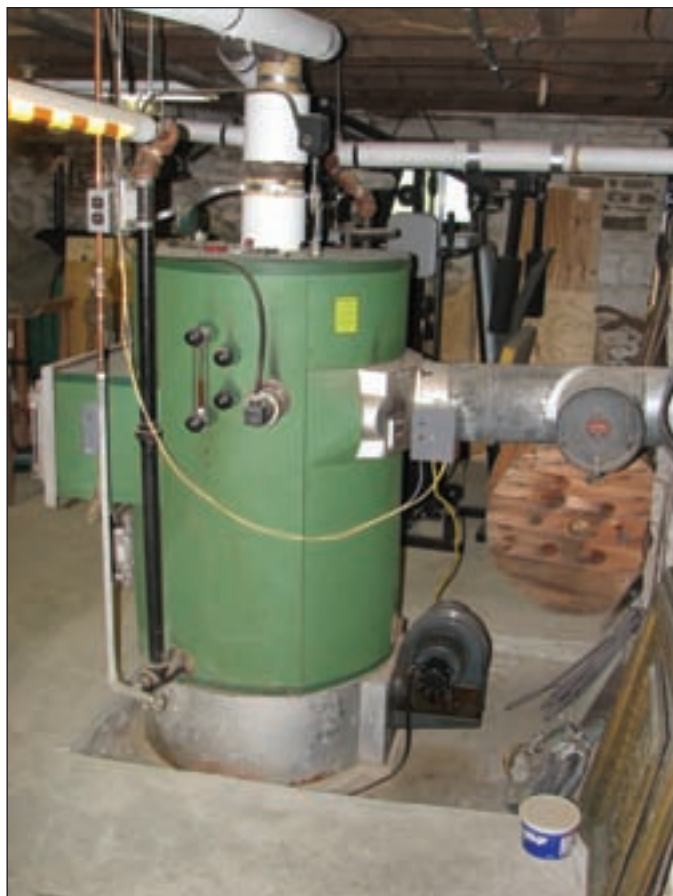
**Photo 5:** The current owner's grandfather was a steamfitter and installed two steam systems in the 1940s. He installed two Kewanee steel oil-fired boilers connected to one-pipe steam systems.

The current owner's grandfather was a steamfitter and installed two steam systems in the 1940s. He installed two

Kewanee steel oil-fired boilers connected to one-pipe steam systems (see photo #5 on page 150). The system featured a combination of column-style cast iron radiators and convectors that he fabricated/welded in his shop (See photo #6 above).

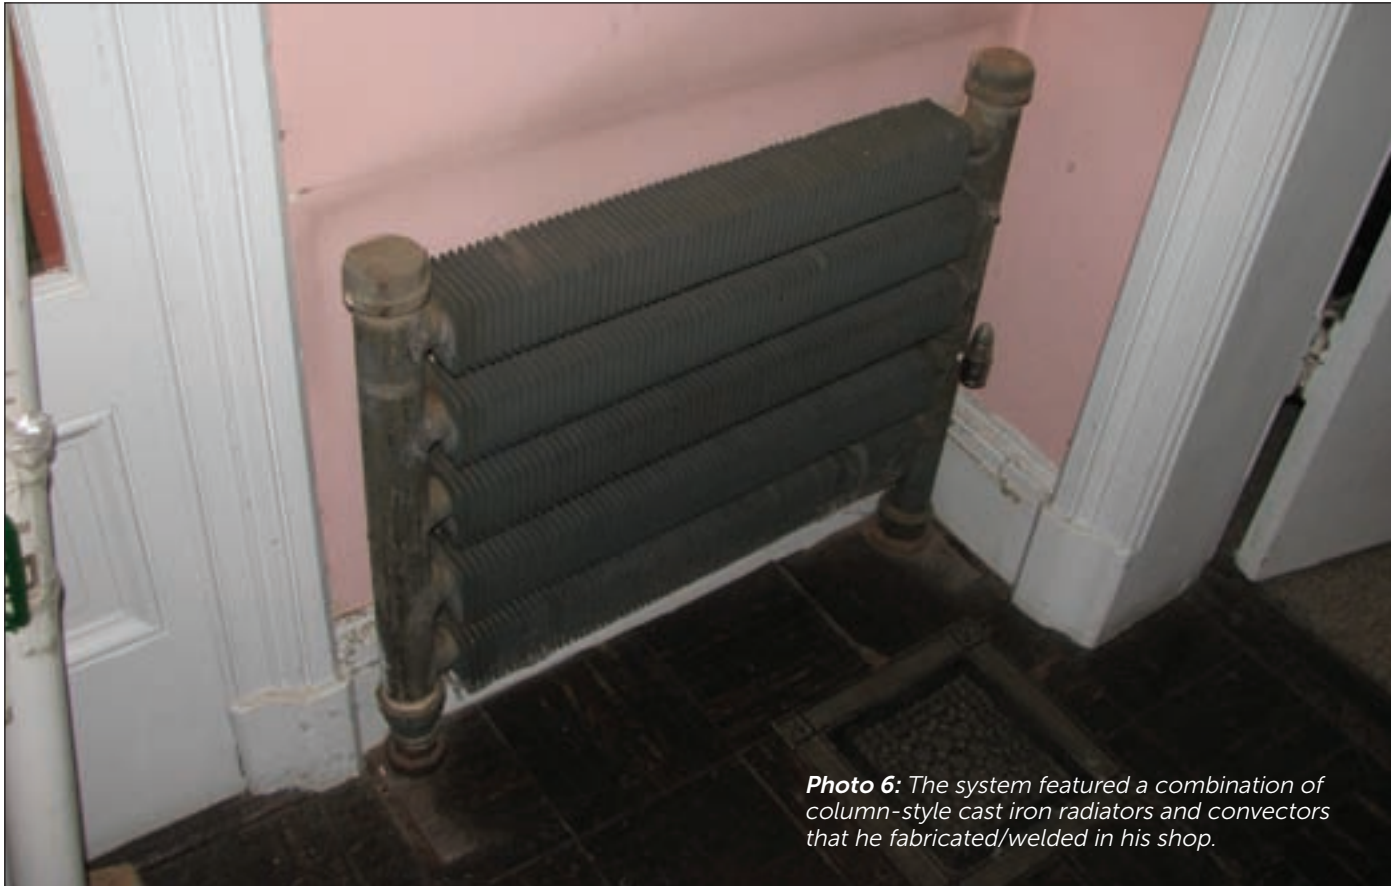
*Photo 6: The system featured a combination of column-style cast iron radiators and convectors that he fabricated/welded in his shop.*

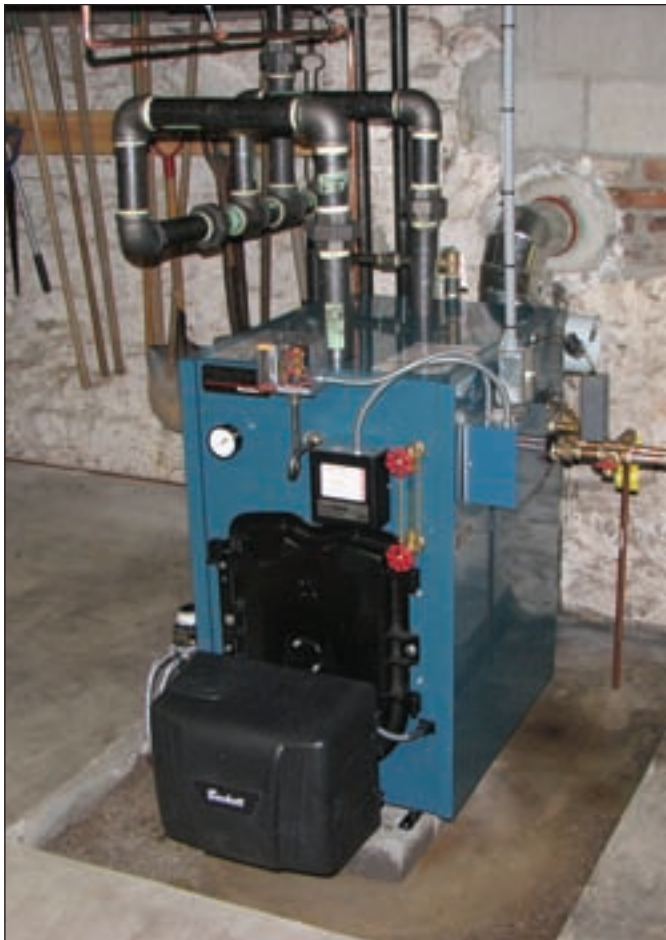
*Photo 7: We replaced the second boiler more recently employing a Burnham MegaSteam cast iron oil boiler.*

We did this job in two stages. We replaced the first boiler about 10 years ago using a Burnham V-8 cast iron oil boiler. We replaced the second boiler more recently employing a Burnham Mega Steam cast iron oil boiler (See photo #7 to the left).

The owner had both chimneys lined with stainless steel liners. We replaced all of the main vents, radiator vents, and a few of the valves that were broken. We ordered an optional header piping kit with the MegaSteam, which streamlined the piping process and minimized the amount of cutting and threading of black steel pipe. We ordered the boiler with an optional tankless coil to feed an aqua-booster tank in the winter. In the summer, the client closes a valve and uses the electric element in the tank for DHW.
