FROM THE FIELD

Commercial DHW

BY DAN FOLEY CONTRIBUTING WRITER

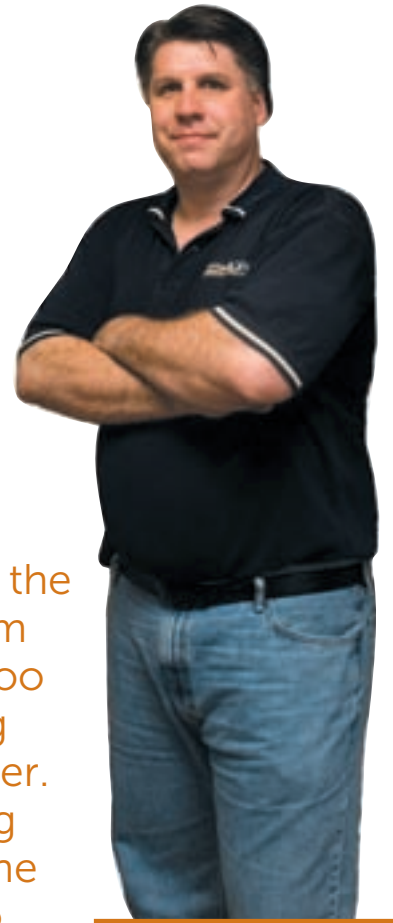
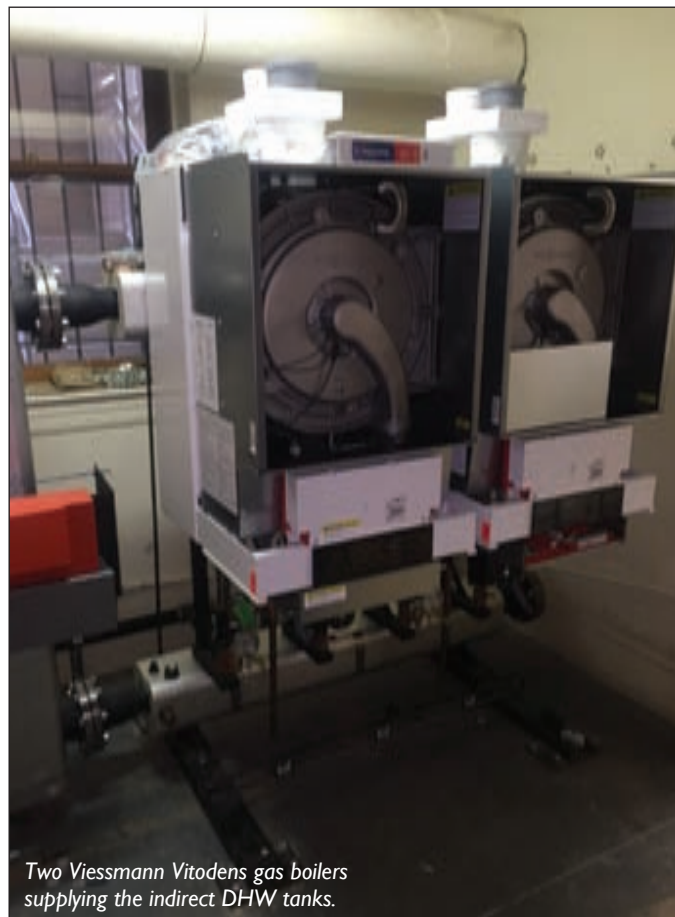
Two Viessmann Vitodens gas boilers supplying the indirect DHW tanks.

I submitted an alternate design and proposal, which was based on these three principles. My design consisted of the following: two Viessman Vitodens commercial boilers (530k BTU each) connected to four Viessmann 120-gal. stainless steel indirect fired storage tanks. Two Wilo ECM pumps provide flow from the boilers to the indirect tanks. One pump is a standby, and they are programmed for auto rotate. If one pump fails, the standby pump comes on automatically.

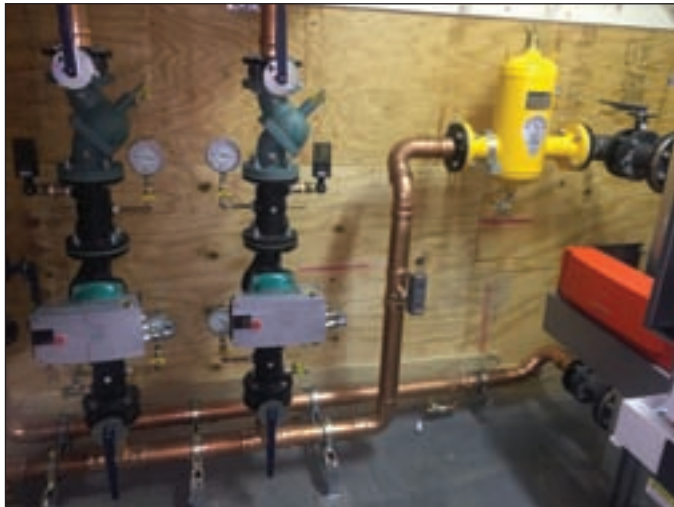
Flow is provided by two Wilo ECM pumps.

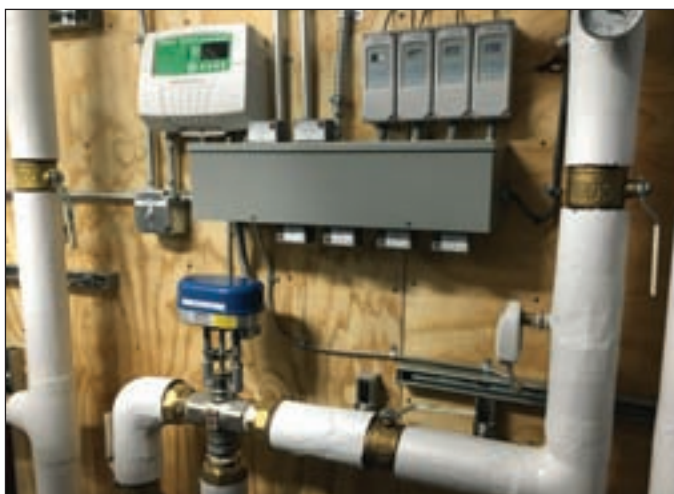
Supply water temperature is maintained at a steady 120 F by the electronic temperature control and the stainless steel motorized tempering valve.

The DHW must have a safe and reliable means of providing tempered hot water to the fixtures. The hard D.C. water presented a challenge. I specified an electronic temperature control system utilizing a stainless steel motorized tempering valve.

The DHW must have a safe and reliable means of providing tempered hot water to the fixtures. The hard D.C. water presented a challenge. I specified an electronic temperature control system utilizing a stainless steel motorized tempering valve. This was piped in with union connections and a second replacement valve was included in my proposal. Isolation valves were installed all around the mixing valve. If, or more likely when, the motorized valve fails due to scale, it can be replaced in 30 minutes, rather than the all-day rebuild required with the previous system.

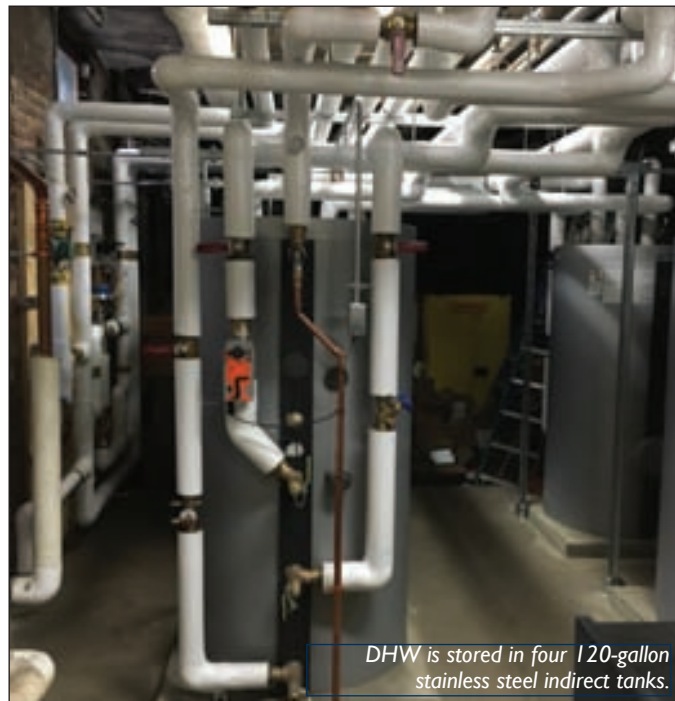
DHW is stored in four 120-gallon stainless steel indirect tanks.
